INDOOR AIR QUALITY REASSESSMENT

**Mt. Greylock Regional High School
Mount Greylock Regional School District
1781 Cold Spring Road
Williamstown, Massachusetts**

Prepared by:
Massachusetts Department of Public Health
Bureau of Environmental Health Assessment
July 2003

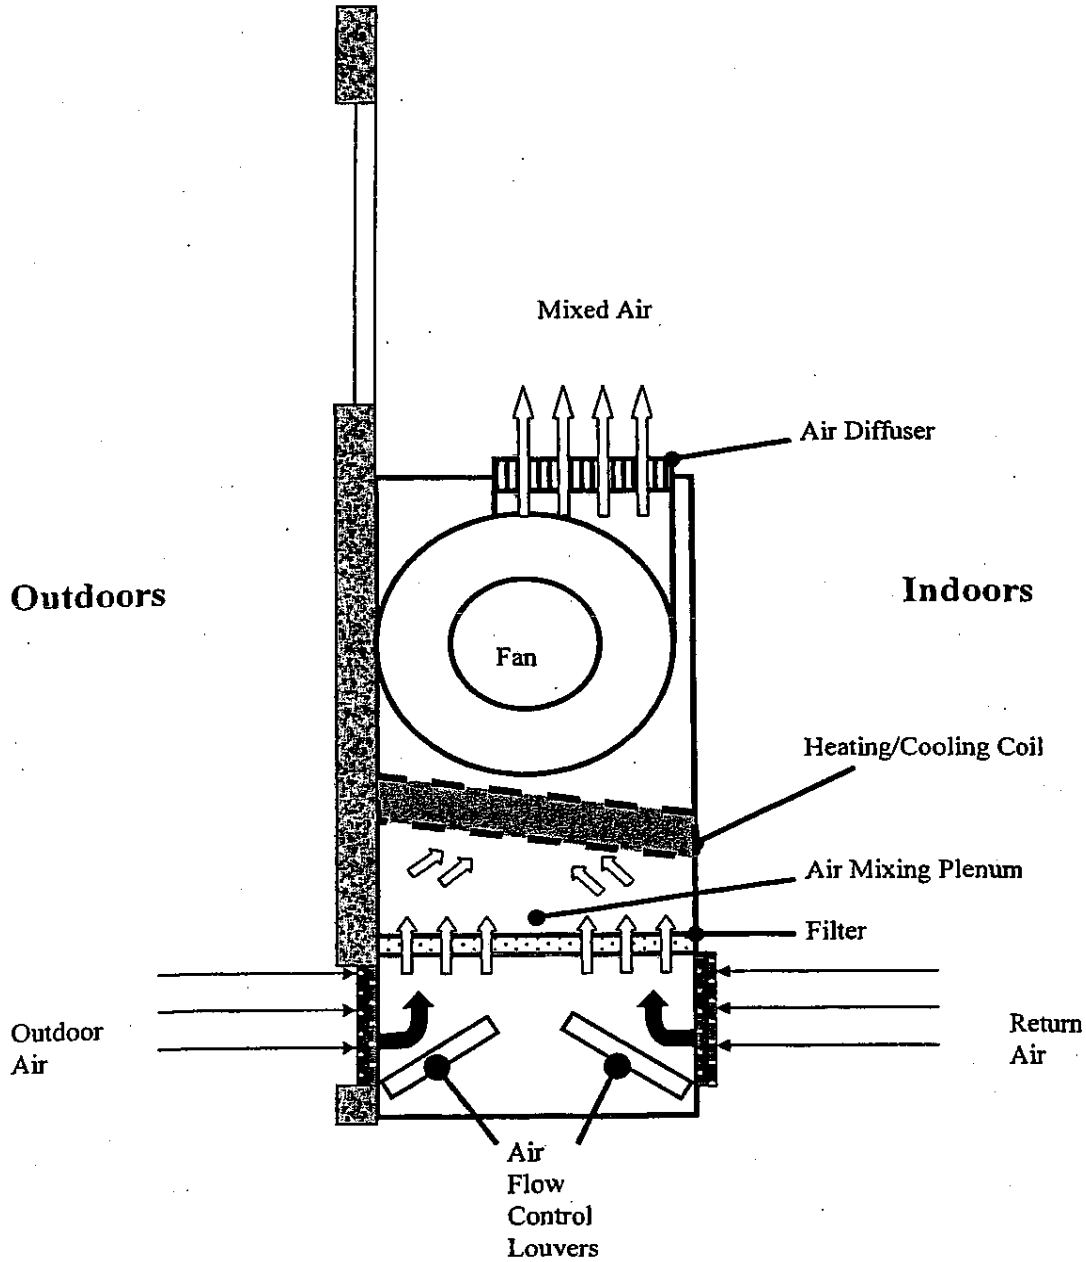
Figure 1
Unit Ventilator (Univent)

univent by motorized fans through fresh air diffusers (see Figure 1). Univents were found turned off in classrooms throughout the school. Obstructions to airflow, such as papers and books stored on univents and bookcases, carts and desks in front of univent returns were seen in a number of classrooms (see Picture 2). Some univents also contained accumulated dirt/debris. These univents should be cleaned before operating to prevent aerosolization of this material.
